FORD:

2011-2015 Explorer

This article supersedes TSB **16-0165** to add a causal basic part number and condition code.

ISSUE

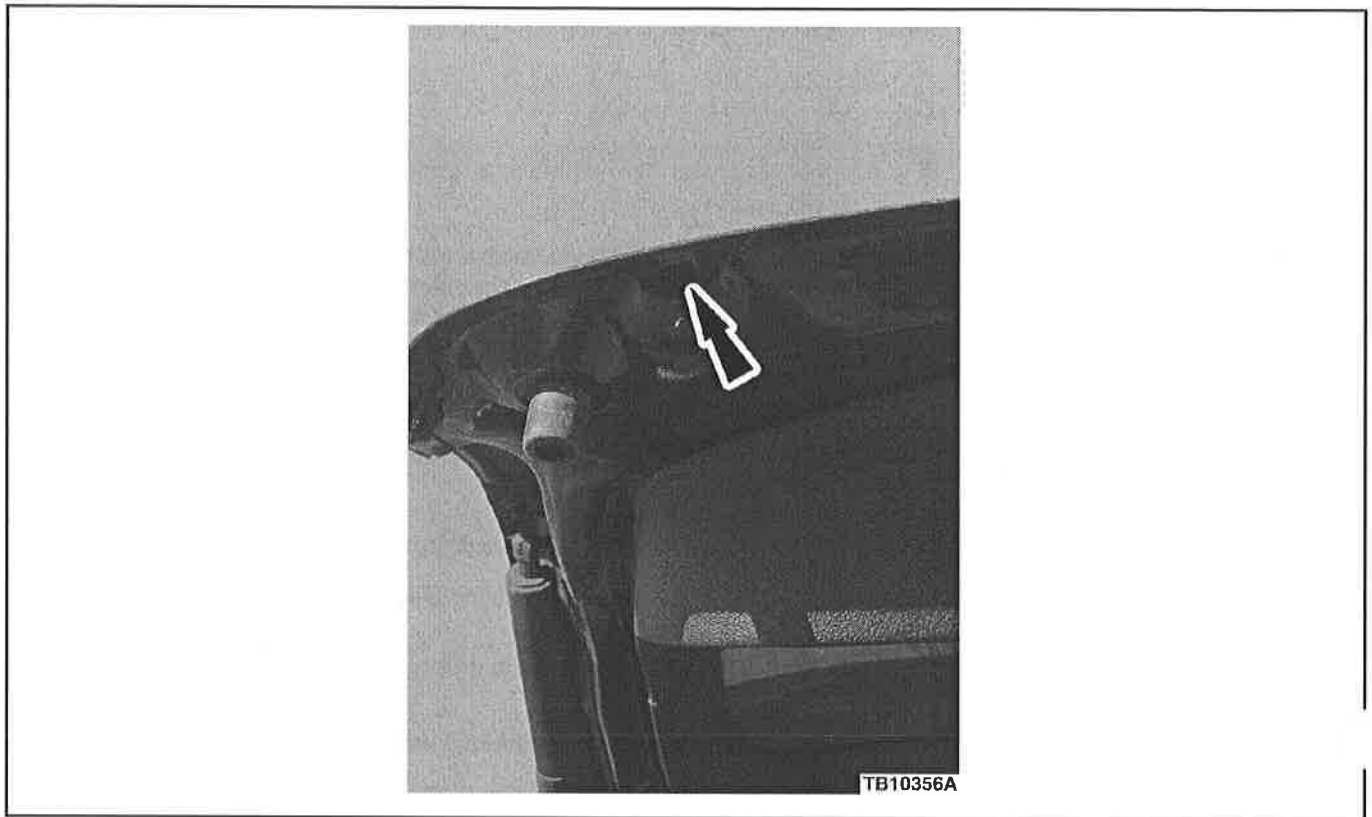
Figure 1 - Article 16-0166

1. Reprogram the heating ventilation air conditioning (HVAC) module to the latest calibration using IDS release 101.03 or higher. Make sure you are connected to the internet when entering module programming to obtain the latest updates. Calibration files may also be obtained at www.motorcraftservice.com.
 - a. When reprogramming the HVAC, IDS will have additional questions which will require a yes response to reprogram the module.
2. Remove the rear bumper cover. Refer to Workshop Manual (WSM), Section 501-19.
3. Remove the left and right tail lamps. Refer to WSM, Section 417-01.
4. Remove the wheel lip mouldings. Refer to WSM, Section 501-08.
5. Open the liftgate and inspect for presence of drain valves in the two (2) drain holes on the left and right side of the liftgate. Are the drain valves present? (Figure 1)

- a. Yes - proceed to Step 7.
- b. No - proceed to Step 6.
6. Install a new drain valve in each of the two (2) drain holes on the left and right side of the liftgate. (Figure 1)
7. Inspect the liftgate seal for damage and proper fit/contact pattern. Adjusting the rear liftgate striker so that the rear hatch seals tighter to the liftgate seal is important. This can be done by loosening the striker and moving it to increase the liftgate sealing pressure.
8. Inspect the left and right side air extractors for proper fit to the body and operation/sealing of the rubber flaps.
 - a. Replace the air extractor if it is warped or damaged or flaps do not lay flush to their sealing surface. (Figure 2)
